Ruins Stabilization in the Southwestern United States

RUINS STABILIZATION IN THE SOUTHWESTERN UNITED STATES

**ROLAND VON S. RICHERT and
R. GORDON VIVIAN**

National Park Service
U. S. Department of the Interior
Washington 1974

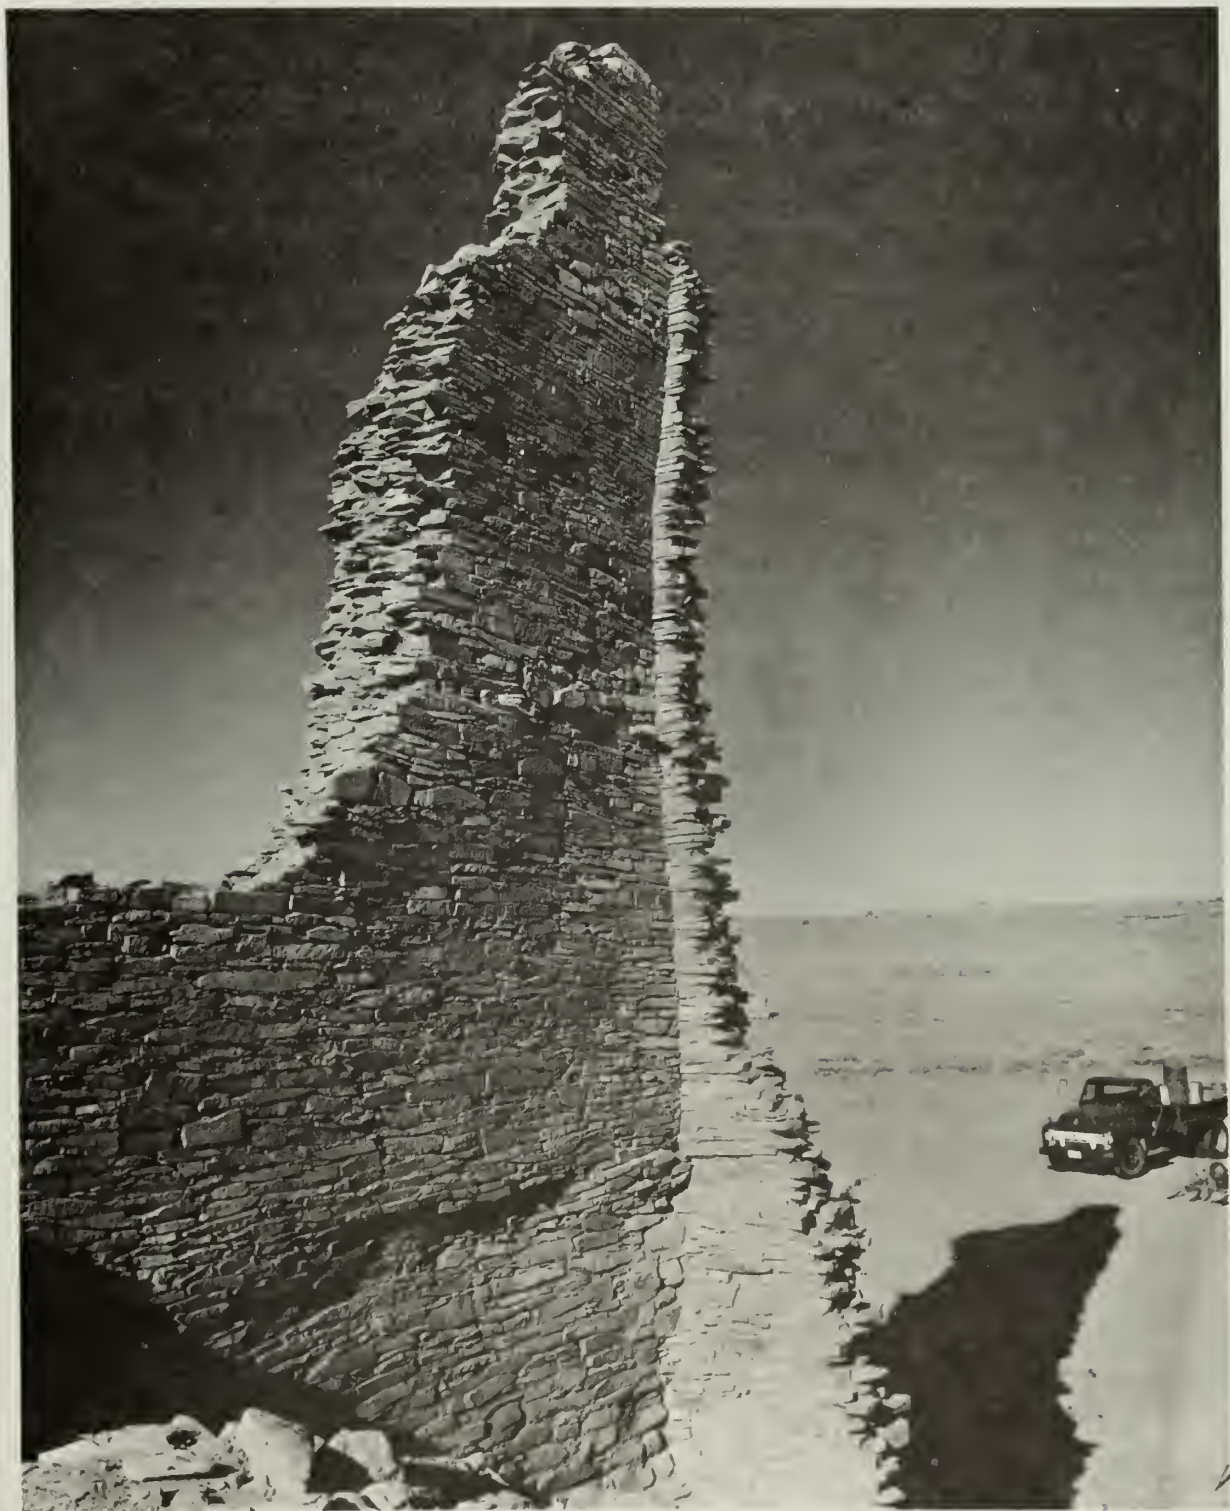
FIGURE 114. View of Tower Kiva showing north wall stub buttressed, cracks repaired, savino sockets re-molded, and facing grouted.

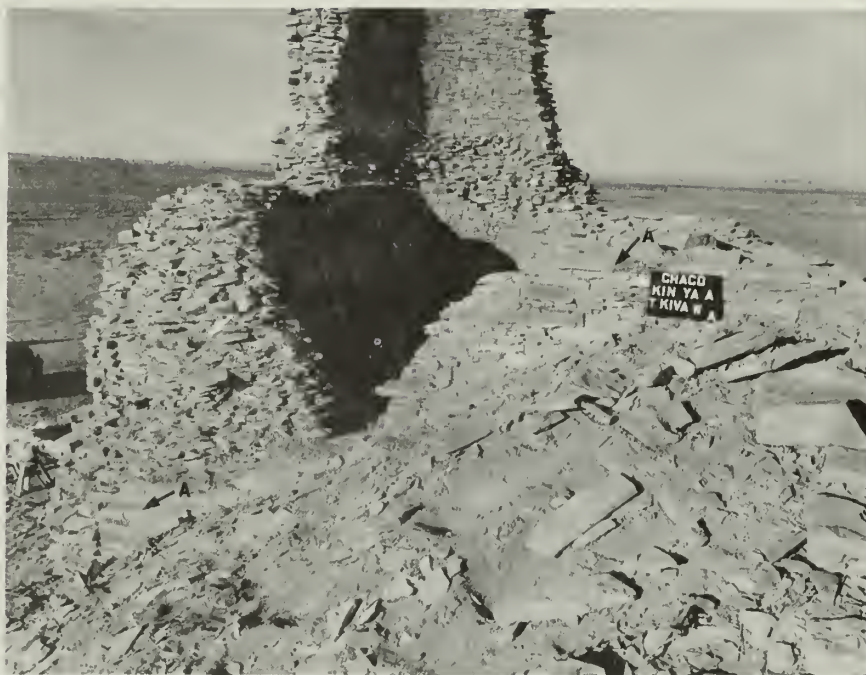
FIGURE 117. Tower Kiva, west wall. This fragmentary section of the square tower enclosing a round one was repaired by resetting the facing (arrow A), capping and grouting the thick core (B).

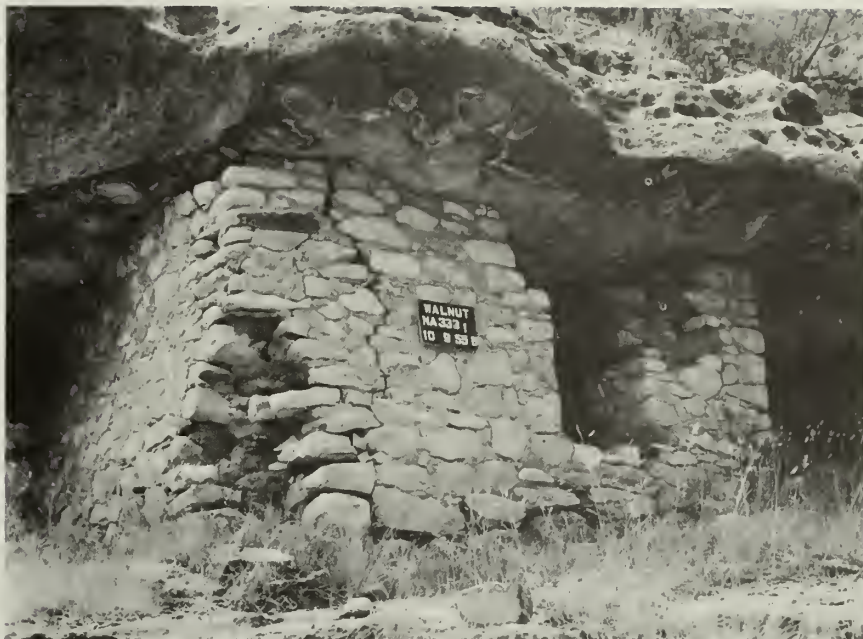
FIGURE 125. Room 1, east exposure, before replacement of fallen corner. (Walnut Canyon National Monument)
